First-generation Low-energy Buildings: Quality of the Thermal Envelope

T. Valdbjørn Rasmussen

Keywords: thermal envelope, quality, low-energy, building, evaluation, thermographic observations, on location

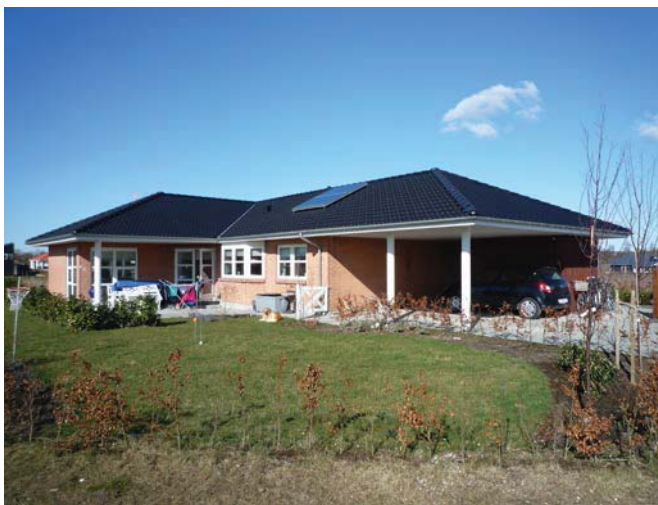
Fig. 1. Three of the dwellings had exterior walls consisting of brickwork walls attached to a lightweight concrete wall that served as the loadbearing inner wall, separated by thermal insulation made of mineral fibre. The dwelling had a

cold attic room. The floor construction consists of a concrete slab on a layer of expanded polystyrene, EPS, insulation on top of a capillary-braking layer. The overall coefficient of heat transmission of the ground deck, roof and exterior walls was 0.1, 0.08 and 0.18 W/m²K, respectively. The concrete slab floor was separated from the strip foundation by 30 mm EPS insulation.

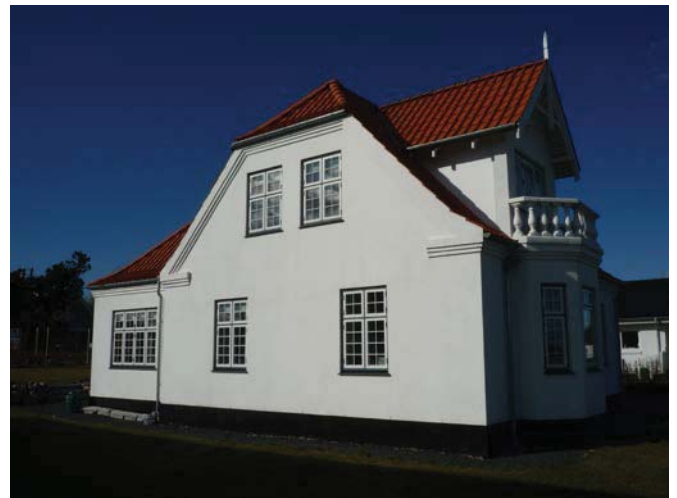
Fig. 2. Two of the dwellings had exterior walls consisting of brickwork walls covered with plaster attached to a wood-stud wall with mineral fibre insulation that served as the load-bearing inner wall. The wood frame wall allowed the vapour barrier to be placed 50 mm into the insulation. The internal surface was gypsum boards. The ceiling of the dwellings was parallel with the roof. The horizontal partition included timber beams. The floor construction consisted of a concrete slab on a layer of EPS insulation on top of a capillary-braking layer. The overall coefficient of heat transmission of the ground deck, roof and exterior walls was 0.11, 0.15 and 0.18 W/m²K, respectively. The concrete slab was separated from the strip foundation by 30 mm EPS insulation.

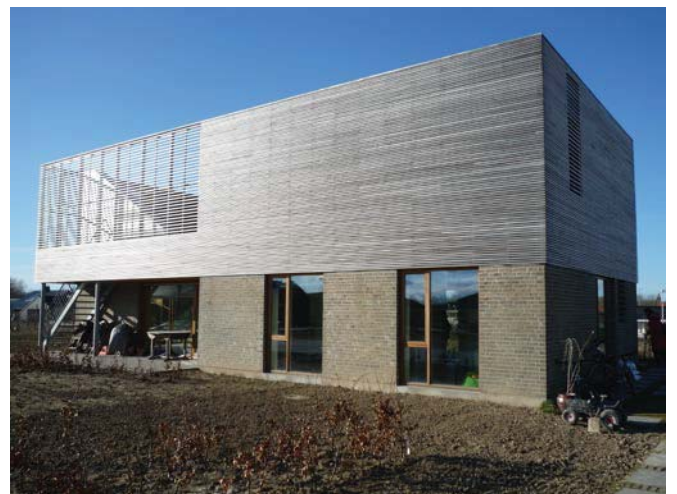
Fig. 3. One dwelling had exterior walls consisting of brickwork walls attached to a lightweight concrete wall that served as the loadbearing inner wall separated by thermal insulation made of mineral fibre. The ceilings of the dwelling were parallel with the roof. The horizontal partition was lightweight concrete. The floor construction consisted of a concrete slab floor on a layer of EPS insulation on top of a capillary-braking layer. The overall coefficient of heat transmission of the ground deck, roof and exterior walls was 0.11, 0.09 and 0.17 W/m²K, respectively. The concrete slab

floor was cast to reach the strip foundation. The strip foundation consisted of blocks of leca separated by thermal insulation.

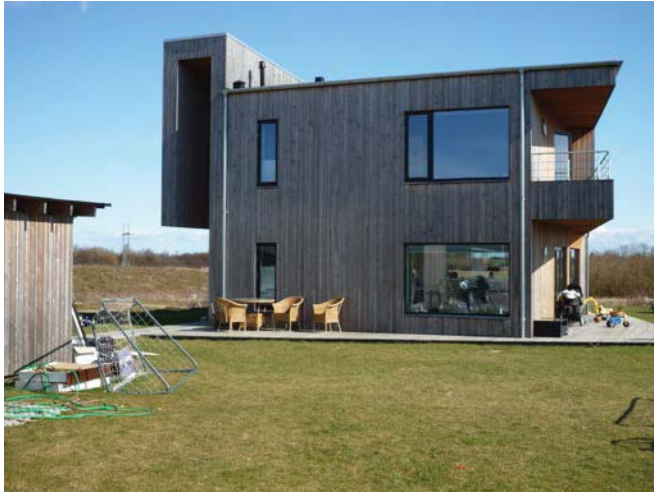
Fig. 4. One dwelling had exterior walls of timber attached to a wood-stud wall with mineral fibre insulation that served as the loadbearing wall. The wood frame wall allowed the vapour barrier to be placed 50 mm into the insulation. The internal surface was gypsum boards. The ceiling of the dwelling was parallel with the roof. The horizontal partition included timber beams. The floor construction consisted of a concrete slab floor on a layer of EPS insulation on top of a capillary-braking layer. The overall coefficient of heat transmission of the ground deck, roof and exterior walls was 0.07, 0.12 and 0.13 W/m²K, respectively. The concrete slab was separated from the strip foundation by 30 mm EPS insulation.

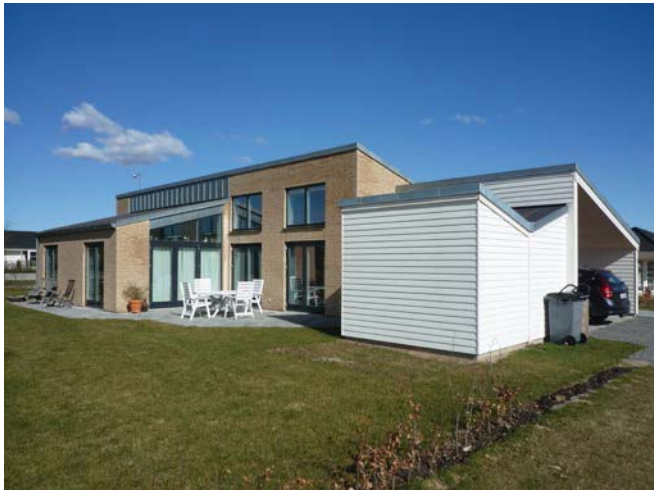
Fig 5. One dwelling had exterior walls of brickwork walls attached to a wood-stud wall with mineral fibre insulation that served as the loadbearing inner wall. The internal surface was gypsum boards. The ceiling of dwelling was parallel with the roof. The floor construction consisted of a concrete slab on a layer of EPS insulation on top of a capillary-braking layer. The overall coefficient of heat transmission of the ground deck, roof and exterior walls was 0.12, 0.13 and 0.20 W/m²K, respectively. The concrete slab was cast to reach to the strip foundation. The strip foundation consisted of blocks of leca separated by thermal insulation.

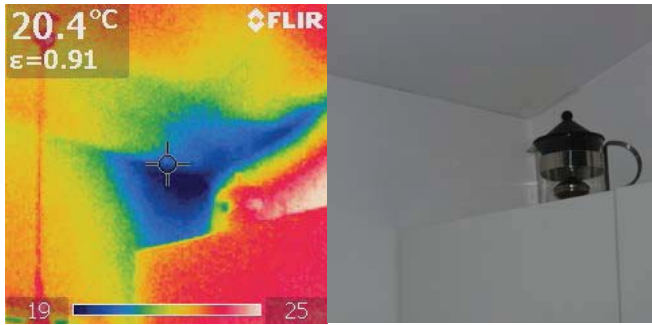
Category A covers the joint between exterior walls and the ceilings for cold attic rooms as well as for the ceiling at horizontal divisions at exterior walls. In addition, at inwards as well as outwards corners at the ceiling, balconies and corners at the entrance are included.

Fig. 6. The joint between the exterior wall, the party wall and the ceiling in the kitchen. The exterior walls were brickwork walls attached to a lightweight concrete wall that served as the loadbearing inner wall separated by thermal insulation made of mineral fibre. The party wall was a lightweight concrete wall. The ceiling consisted of two layers of gypsum board attached to laths with insulation material between and above the laths. The thermal insulation was made of mineral fibre placed towards the ventilated cold attic room. A PE vapour barrier was placed behind the gypsum boards. On the thermographic picture to the left, the dark blue colour represents 19 °C and the yellow colour represents 23 °C. The picture to the right is an ordinary photo.

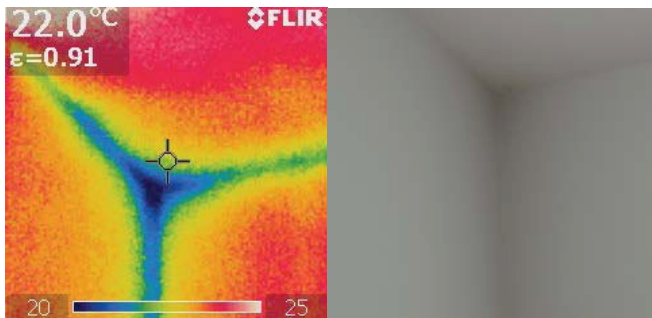
Category B covers vertical corner between exterior walls both at inwards as well as outwards corners from floor to ceiling.

Fig. 7. The joint between two exterior walls at the ceiling in a combined living room and kitchen-dining area. The exterior wall was a brickwork wall attached to a wood-stud wall with mineral fibre insulation that served as the loadbearing inner wall. The internal surface consisted of gypsum boards. The ceilings of the dwellings were parallel with the roof. A PE vapour barrier was placed between the two layers of gypsum. Thermal insulation of mineral fibre was placed between the rafters in the roof construction. On the thermographic picture to the left, the dark blue colour represents 20 °C and the red colour represents 25 °C. The picture to the right is an ordinary photo.

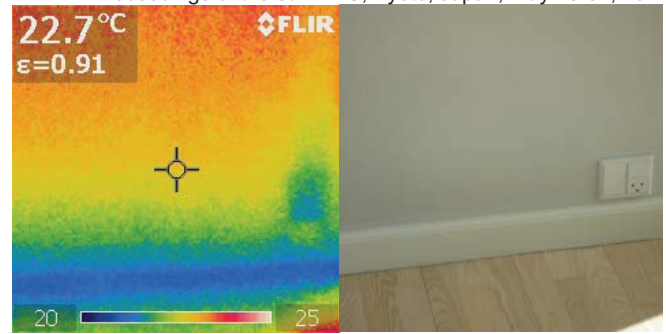
Category C covers cold skirting boards and was observed in a limited number of dwellings. Cold skirting boards along the exterior wall were only observed at the strip foundation at the ground floor.

Fig. 8. The cold skirting board along the exterior wall towards the floor in the combined living room and kitchen-dining area. The exterior wall was a brickwork wall attached to a lightweight concrete wall that served as the loadbearing inner wall separated by thermal insulation of mineral fibre. The floorboards were 14 mm parquet on polyester felt. The ground deck was a 100 mm concrete slab on 275 mm coated loose light clinkers. The strip foundation consisted of two sections of two lightweight concrete blocks separated by 100 mm thermal insulation placed on top of concrete cast to reach stable ground at 0.9 m below ground level. On the thermographic picture to the left, the dark blue colour represents 20 °C and the yellow colour represents 23 °C. The picture to the right is an ordinary photo.

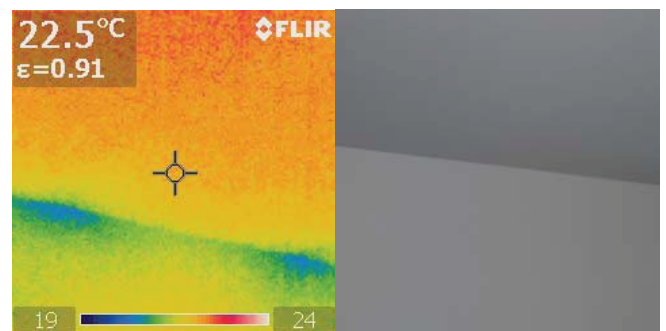
Category D covers cold joints between the exterior wall and the ceiling and was made in a limited number of dwellings. The location of rafters placed on heavy back walls and wood-stud back walls was observed by use of thermographic observations. The locations of the rafters were shown as spots at regular intervals with a lower temperature than was observed at the overall thermal envelope, the exterior wall and the ceiling.

Fig. 9. Joint between the exterior wall and the ceiling in the utility room. The exterior walls were brickwork walls attached to lightweight concrete walls that served as the loadbearing inner wall separated by thermal insulation of mineral fibre. The ceiling consisted of two layers of gypsum board attached to laths with insulation material between and above the laths. The thermal insulation was made of mineral fibre placed towards the ventilated cold attic room. A PE vapour barrier was placed behind the gypsum boards. On the thermographic picture to the left, the dark blue colour represents 19 °C and the red-yellow colour represents 24 °C. The picture to the right is an ordinary photo.

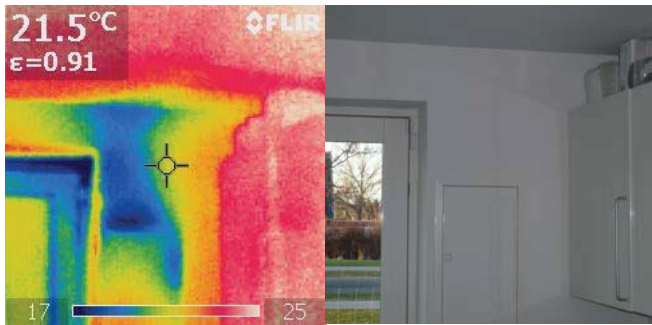
Category E includes inhomogeneity in the thermal envelope seen both in the exterior walls and towards the ceiling. The areas represent thermal bridges or areas with a decreased thickness of the layer of the thermal insulation.

Fig. 10. Joint between the exterior wall and the ceiling. The exterior walls were a brickwork wall attached to a lightweight concrete wall that served as the load-bearing inner wall separated by thermal insulation made of mineral fibre. The ceiling consisted of two layers of gypsum board attached to laths with insulation material between and above the laths. The thermal insulation was made of mineral fibre placed towards the ventilated cold attic room. A PE vapour barrier was placed behind the gypsum boards. On the thermographic picture to the left, the dark blue colour represents 17 °C and the yellow colour represents 24 °C. The picture to the right is an ordinary photo.

Measurements revealed that when constructing high-performance thermal envelopes, special care must be taken in order to avoid cold areas in the thermal envelope, shown as a result of inhomogeneity of the thermal envelope i.e. changed thickness of the thermal insulation; cold areas in the thermal envelope along the ceiling and; cold joints between building components, illustrated as Categories E, F and G, respectively.

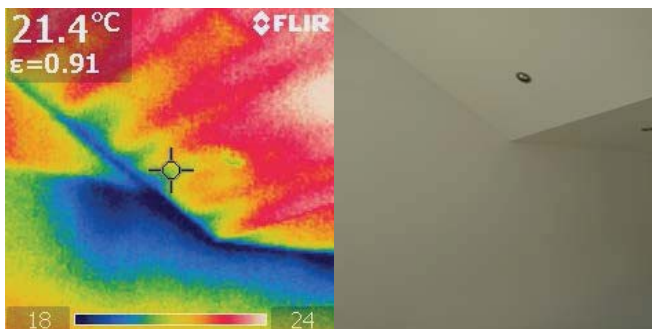
Category F includes inhomogeneity in the thermal envelope at the ceiling. The areas represent thermal bridges not related to areas with a less thick layer of thermal insulation. The thermal bridges were observed as the result of cold outside air penetrating into the thermally insulated layer. The cold outside air sweeps through the wind barrier and infiltrates the thermally insulated layer as a result of gaps in the joint between wind barriers. Gaps within the thermal insulation allow the cold outside air to spread far across the ceiling.

Fig. 11. Joint between the exterior wall and the ceiling in the kitchen. The kitchen-dining area was combined with the living room. The exterior walls of brickwork walls were attached to a lightweight concrete wall that served as the loadbearing inner wall separated by thermal insulation made of mineral fibre. The ceiling consisted of two layers of gypsum board attached to laths with insulation material between and above the laths. The thermal insulation was made of mineral fibre placed towards the ventilated cold attic room. A PE vapour barrier was placed behind the gypsum boards. On the thermographic picture to the left, the dark

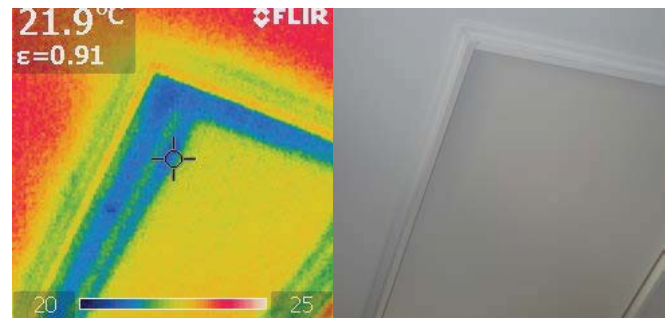
Category G include joints between different building components. Joints between building components were observed at door frames, window frames, at access hatches to the attic room and duct for technical supply installations going through the thermal envelope at ceilings or exterior walls.

Fig. 12. Joint between the hatches to the attic room and the ceiling of the utility room. The ceiling consisted of two layers of gypsum board attached to laths with insulation material between and above the laths. The thermal insulation was made of mineral fibre placed towards the ventilated cold attic room. A PE vapour barrier was placed behind the gypsum boards. On the thermographic picture to the left, the blue colour represents 20 °C and the red colour represents 25 °C. The picture to the right is an ordinary photo.
